CTA Acoustics, Inc: Combustible Dust Fire and Explosions

Corbin, KY, February 20, 2003

Facilitator Resources

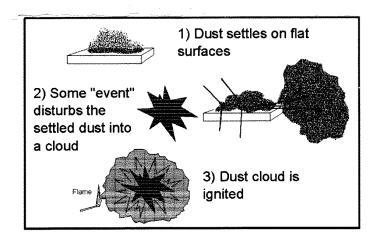
Figure 12. Mechanism for a dust fire or explosion.

Mechanism of dust fire/explosion
